KOP 24

Eureka-Palisade RR Grade

Figure 3.9-25

Falcon to Gonder Project EIS

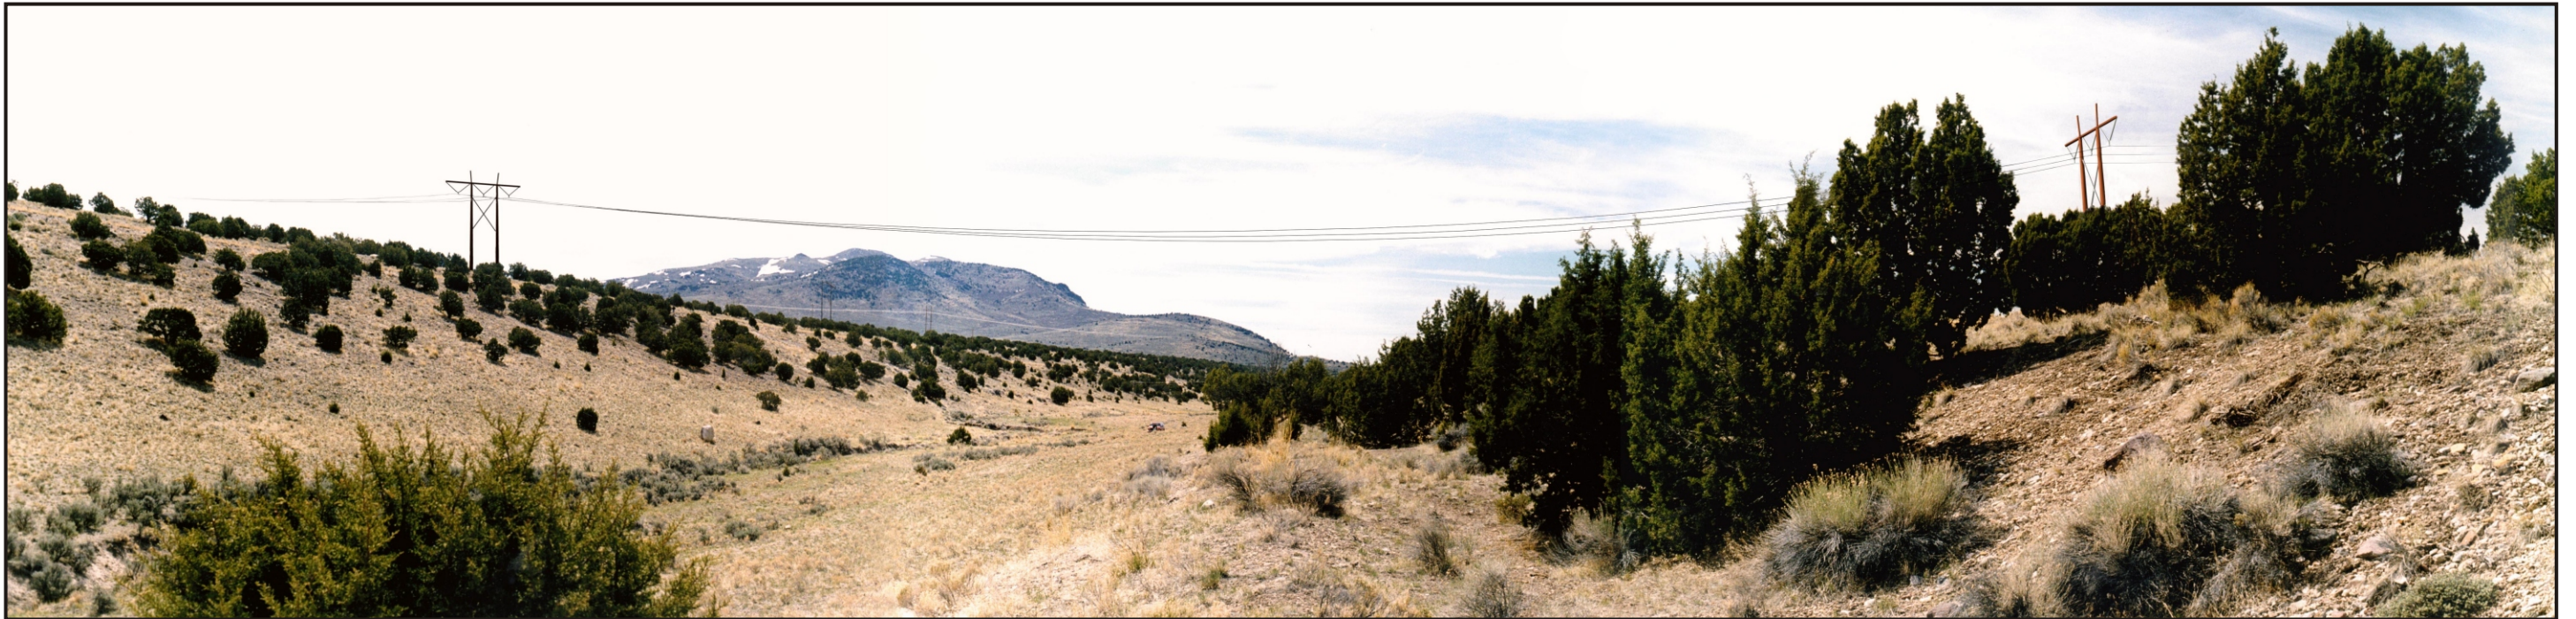
Future Conditions

Summary of Visual Changes

T/L Distance from Viewer: Middleground to foreground crossing views

T/L Prominence in Landscape: High - prominently set on the tops of the enclosing landforms

Existing Modifications: Two existing wood pole transmission lines cross the railroad route approximately 1000 feet to the south

Contrast Rating: Strong

VRM Class: III

Visual Impact Rating: High
